Rensdyrvej 8, Vipperød

The house was built in 1950 and used for housing the principal of the school.

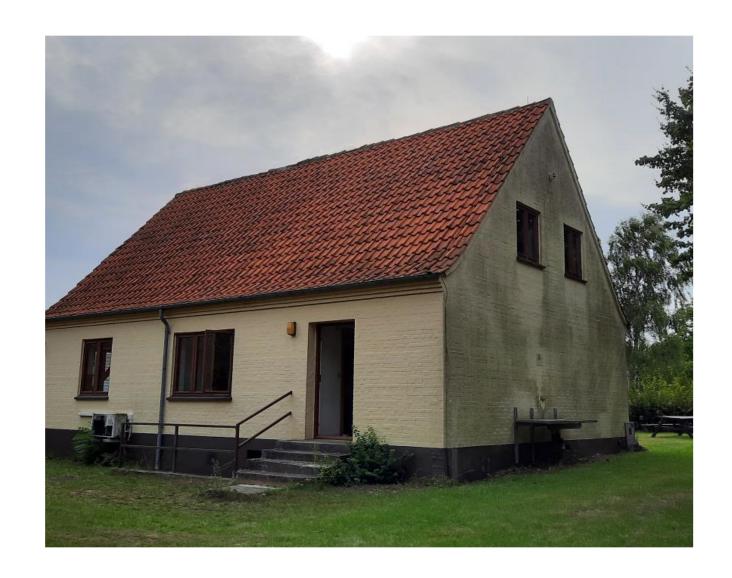
Roof tiles

The tiles have been taken down one by one, cleaned from mortar on the back side, then stacked on pallets.

The surface has a fouling off alges that need to be cleaned.

Dismantling of the tiles and stacking on pallets has taken approximately 130 manhours, equivalent to one hour per m2.

Total, - 15 pallets, tiles are stacked in two layers of 14 bundles, with 5 tiles in each bundle. Total 2,100 usable tiles

The roof area was estimated to 135 m2, approximately waste is 2,5 m2.

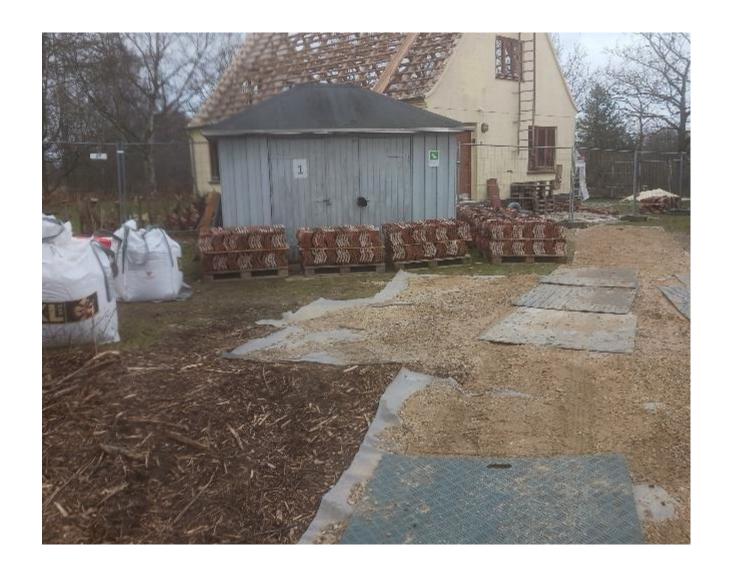
Dismantling of roof structure, rafters, battens and layer of beams

Dismantling woodwork from the roof approx. 50 hours

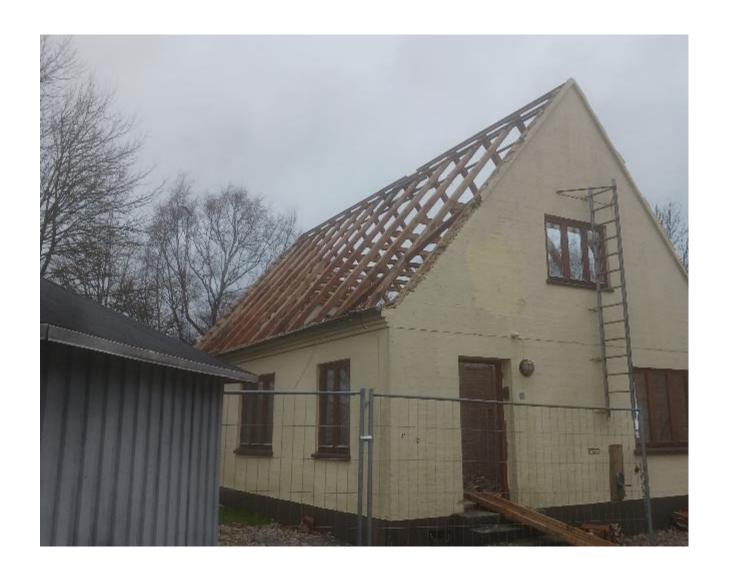
Roof construction

Removal of the ceiling and cleaning of boards and battens for nails and plaster approx. 30 hours

Beams 5x6"- 24 pcs of 3,5 m

Rafters 5x5" - 20 pcs of 5,5 m

Rafter, horizontal 4x4" - 15 pcs of 3 m

Floorboards 5/4 x 5"- 110 pcs of 4 m

Formboards wood 3/4 x 4" - 160 pcs of 3 m

Formboards, wood 3/4 x 4" - 50 pcs of 3.5 m

Battens - 80 pcs of 3,5 m

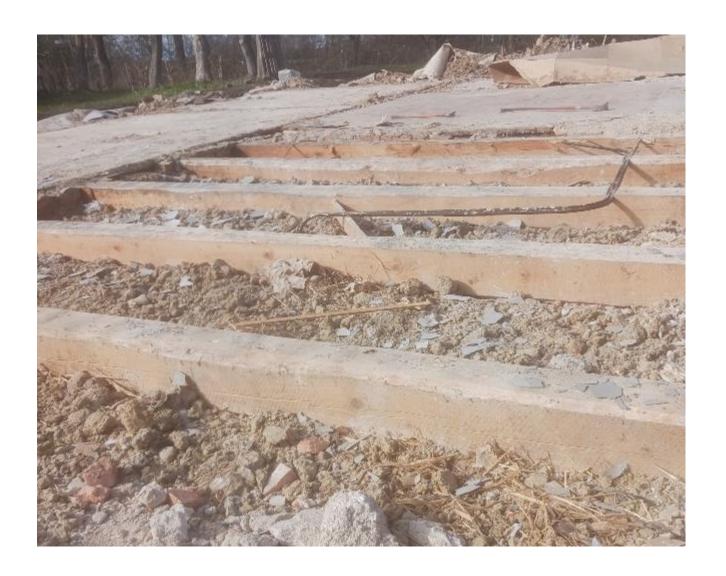
Floor

The floorboards have been cleaned of nails.

The joint and groove are partially damaged when removing the boards.

The boards measure about 26 mm in thickness and 123 mm in width.

The utilization is approx. 22 x 100 mm if you cut the edges and plane the boards to size in thickness.

There is approx. 110 m2 in all.

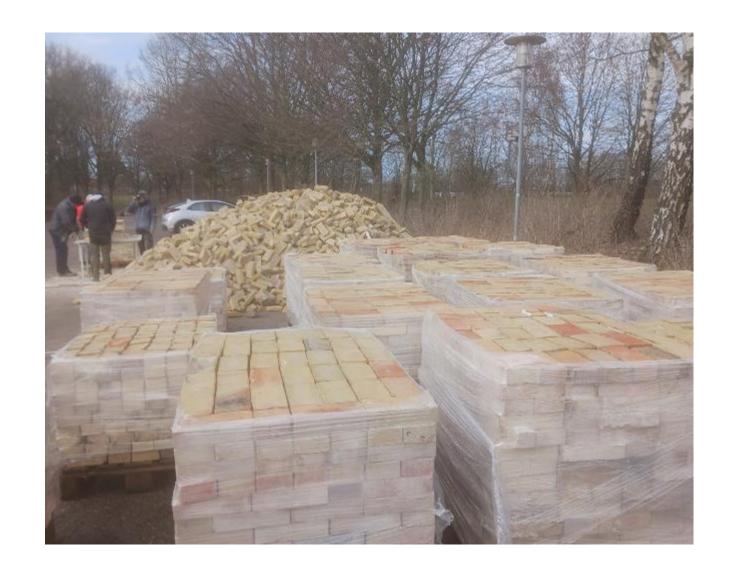
Bricks

Hand cleaned stone from Vipperød 8

The stone has been taken down one by one and hand cleaned from lime mortar.

7000 whole and approx. 3500 half stones have been cleaned, consumption approx. 360 hours

The house has been bricked in half-stone pattern compounds.

The stones in the façade are predominantly yellow. The backwall stones are red, yellow and flamed.

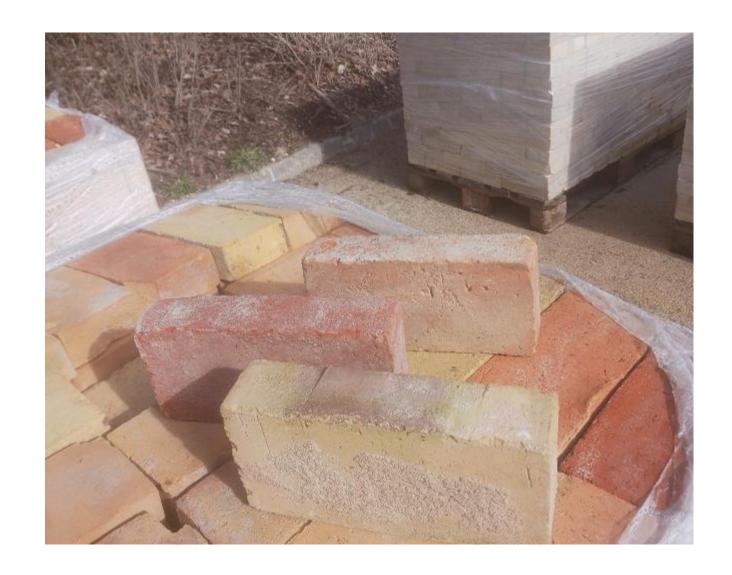
Hollow bricks from Holbæk Svømmehal

Hollow stones from Holbæk Svømmehal.

In the mortar for the bricklaying there was used mixture of lime and cement. It was not expected that it was possible to clean the bricks for reuse.

Normally this type of bricks will be destroyed when taken down as the cement mixture is stronger than the stones.

The masonry was knocked down with an excavator, - on site, part of it was cleaned by hand. Another part was loaded in a container, - moved to Vipperød, and cleaned there, due to the local site conditions.

10,300 bricks was saved in full size and about 600 half. The bricks was cleaned by hand and stacked on pallets. Approx. 165 m2

Time consumption is approx. 300 hours, equal to $\frac{1}{2}$ hour per square meter piecework price is around DKR 7.50 per stone.

The hollow stones has patina and damages, they can not be used as façade bricks.

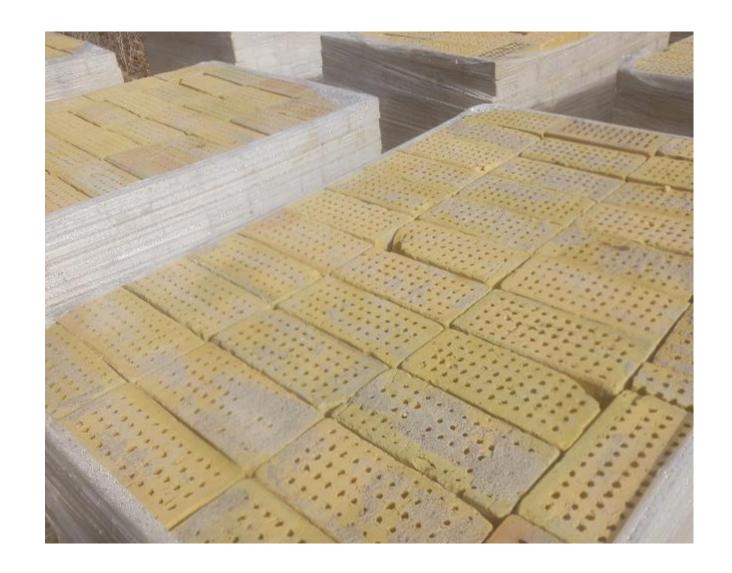
Building site

Additional whole and half stones are expected from cleanup around the building, as well as the remaining part of the basement.

The bricks have a front and back side. We tried to remove the paint with a pressure washer without success.

It will be possible to remove the paint by sandblasting, which will leave patina, - reduce living time as the incandescent shell of the stone will be removed.

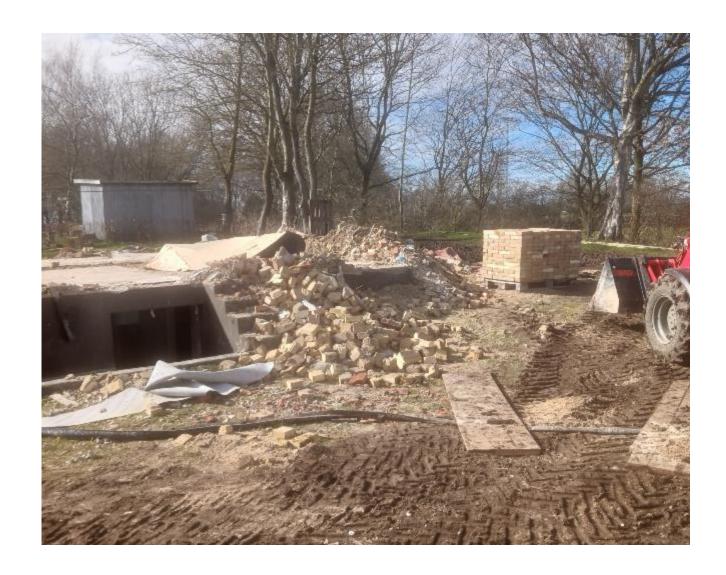
Rapport

Image and excerpt of the material study

When finished we had a total of 8000 whole stone and 4000 half stones, same as 158 m².

The report states 158 m2, but the actual no is approx. 230 – 240 m2 in total.

All stones less tan half is not utilized, - some has been grooved out for electrical wiring and water installations and other damages.

Consumption is 63 stones per m2

The utilization rate is 66 %

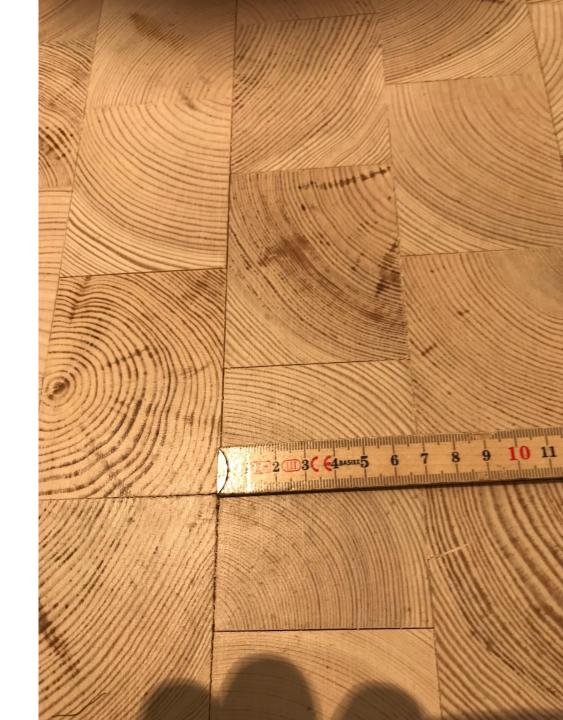
Recycling

Use of rafter wood for wooden floor.

Rafter wood is cut up into slices of 16-20 mm thickness and glued to the floor plate with cam joints. Bricks are sanded and surface treated.

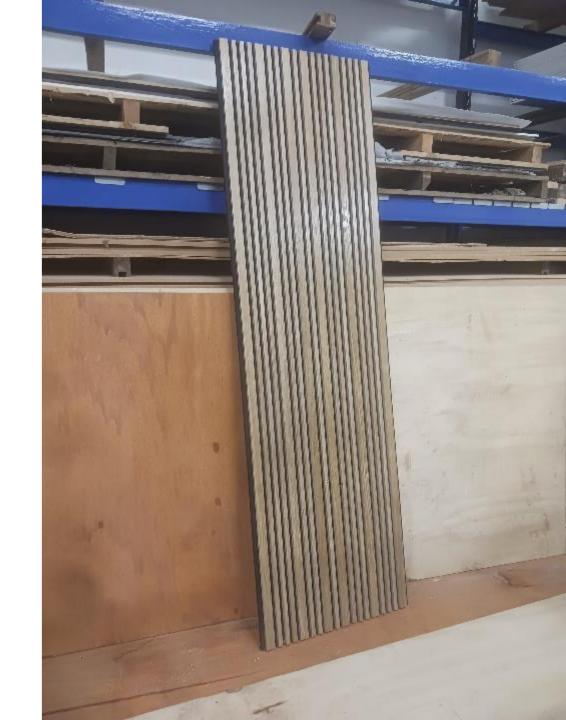
Recycling

The use of floorboards and formwork for sound panel walls. Wood is cut up into moldings of varying widths, 19-32 mm, and thicknesses, 16-19 mm. Panels are made in 60 cm modules at a height of 240 cm.

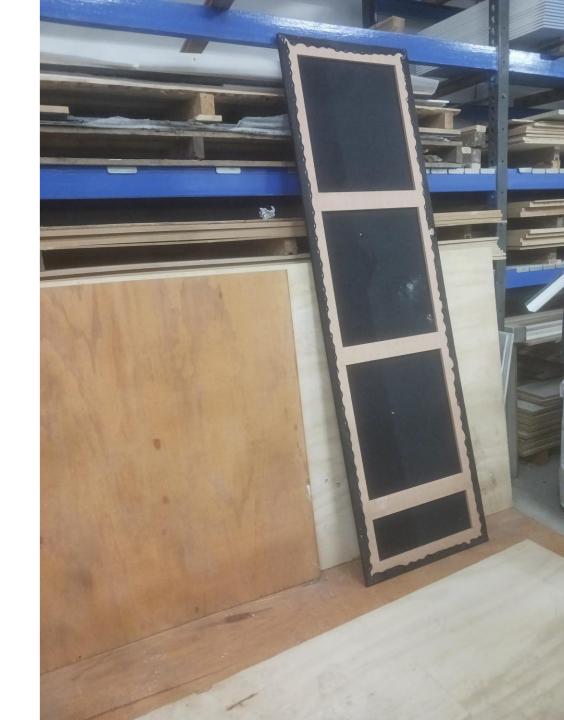
Recycling

Panels are attached to a 16 mm frame, which is provided with a woolen fabric.

The sound panels are mounted on a base of fire-treated Kerto 45x45 mm per 600 mm. Distance between joists is filled with mineral wool
